Manhole Inspection Summary

Manhole # S43A2_021MH

Insp Date: **12/12/07 8:05 AM**

Location Address: **3600 Saint Margaret St**

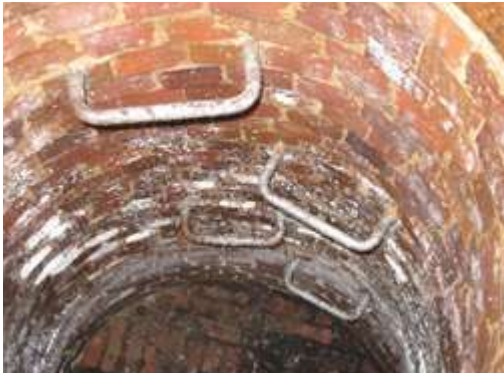
Steps Count: **4** Missing: **0** ☐ Corroded

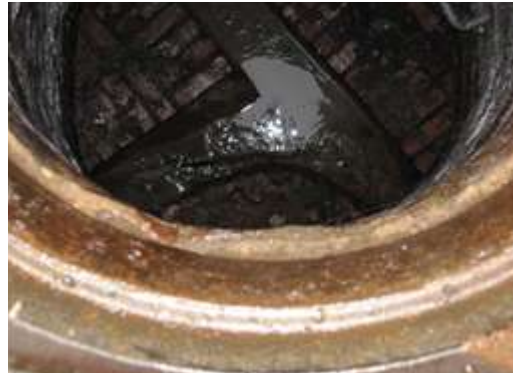
Defect 1

Frame Offset: **0.5** (in.) Condition: ☒ Sound ☐ Cracked ☐ Leaks

Frame offset

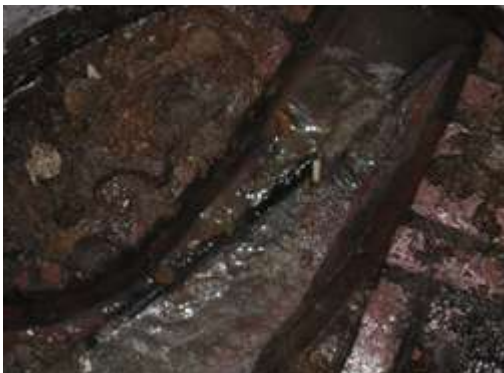
Defect 2

Pole in channel

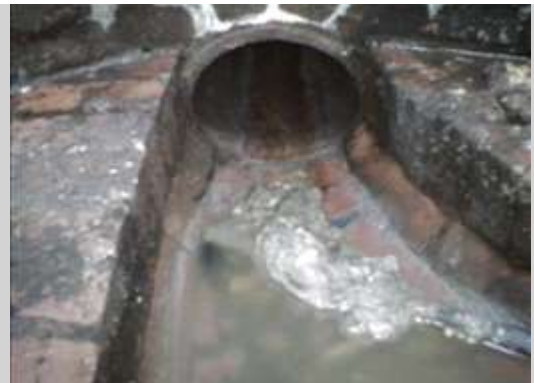
12 O'Clock Outflow

8 in. Circular Gravity Sewer
Pipe Out @ 12 O'Clock

Pipe Height: **9.6** (in.) Rod and Bar (Angled)
Pipe Material: **Clay** ☐ Pipe Lined
Invert Depth: **8.50** (ft.) Flow Characteristics: **Fast**
Deposits: ☒ None ☐ Mud ☐ Sludge ☐ Debris ☐ Grease
Silt Depth: (in.) Deposits Extent:
Infiltration: **None** Pipe Seal Cond: **Sound**

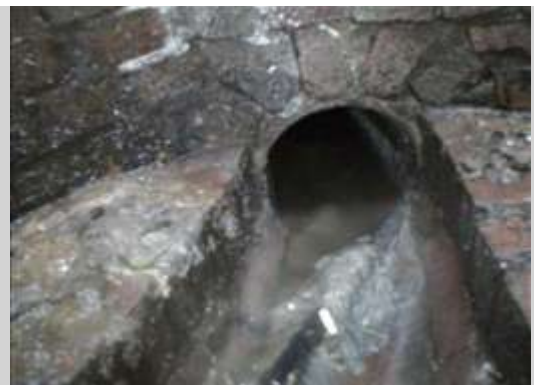
3 O'Clock Inflow

8 in. Circular Gravity Sewer
Pipe In @ 3 O'Clock

Pipe Height: **8.4** (in.) Rod and Bar (Angled)
Pipe Material: **Clay** ☐ Pipe Lined
Invert Depth: **8.18** (ft.) Flow Characteristics: **Fast**
Deposits: ☒ None ☐ Mud ☐ Sludge ☐ Debris ☐ Grease
Silt Depth: (in.) Deposits Extent:
Infiltration: **None** Pipe Seal Cond: **Sound**

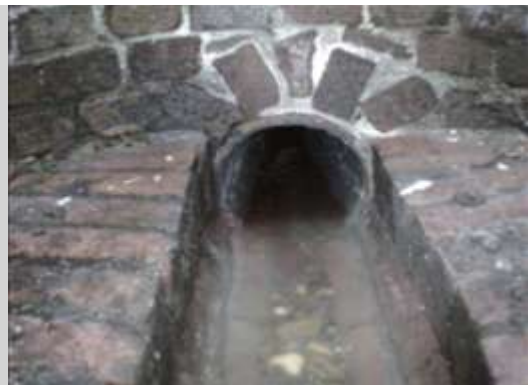
6 O'Clock Inflow

8 in. Circular Gravity Sewer
Pipe In @ 6 O'Clock

Pipe Height: **7.2** (in.) Rod and Bar (Angled)

Invert Depth: **8.31** (ft.) Flow Characteristics: **Slow**

Infiltration: **None** Pipe Seal Cond: **Sound**
